TSB130055

Technical Service Bulletin

Heavy Duty Thermostat Stuck Open and/or Missing Flange Seal

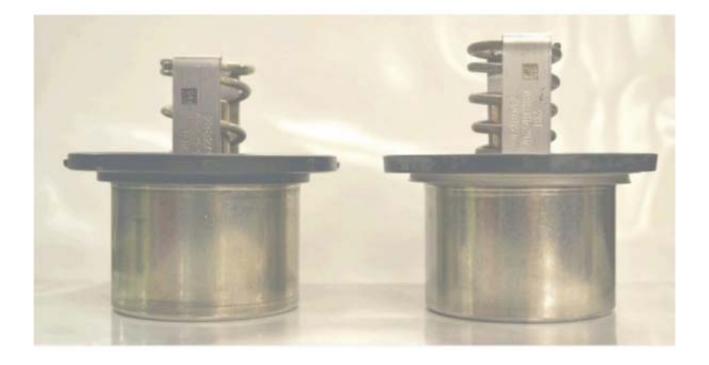
Figure 1: Old Thermostat, Part Number 4318197 vs New Thermostat, Part Number 4318947

Heavy Duty (HD) engines have been experiencing excessive cooling of the engine coolant as a result of thermostat failures. This document addresses two failure modes for HD thermostats: thermostat stuck/seized in the open position and thermostat flange seal failures. During operation, fluid forces were greater than the return force of the spring, preventing the thermostat from closing fully and leading to a stuck open/seized thermostat. Also, during operation, the elastomer covering the thermostat flange fails, causing the elastomer seal to chunk out and in some cases a loss of the elastomer seal. Both failures lead to excessive cooling by allowing for continuous coolant flow to the radiator.

Cases have been reported in which repair facilities have noticed the thermostat valve stuck open in the thermostat housing cover. When they remove the thermostat from the thermostat housing cover the thermostat closes and no longer appears to be stuck open. A thermostat in which the elastomer seal has failed will show a loss of elastomer material on the thermostat flange seal exposing the metal flange.

A new thermostat has been released to address both the stuck open and the flange seal failure modes that were reported. The new Cummins Part Number is 4318947, with the engine serial number (ESN) firsts from the plant in Table 1: ESN Firsts below. This new thermostat design has a higher force return spring which resulted in taller spring retaining arms. The flange seal of

the thermostat has reverted back to a previous design using a 3-piece construction. This 3-piece flange consists of a metal flange, elastomeric seal, and steel retaining ring. Refer to Figure 1: Old Thermostat, Part Number 4318197 vs New Thermostat, Part Number 4318947, below for comparison of old and new thermostat.

<u>NOTE</u>: This new thermostat, Part Number 4318947, is not compatible with engines assembled with dual thermostat housing options. The result of longer spring and spring retaining arms results in contact with the dual thermostat housing, preventing the thermostat from functioning properly. For engines using dual thermostat housing, use Part Number 4336659 for repairs.
